## ADDRESSING URM SEISMIC RISK IN VICTORIA, CANADA

### ABSTRACT

**KEYWORDS:** unreinforced masonry, seismic risk, seismic retrofit, Victoria, Christchurch

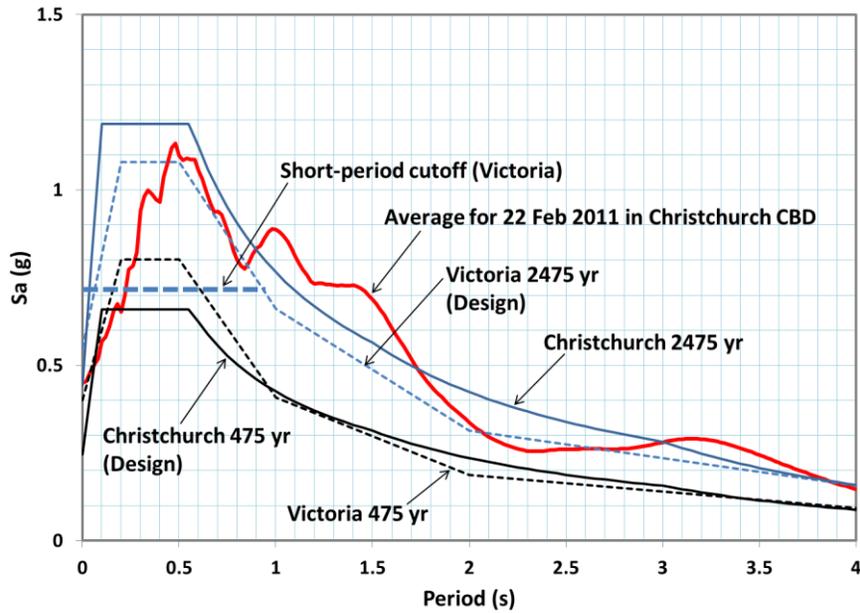
**Figure 1: Comparison of design spectra for Christchurch and Victoria**

The Canterbury Earthquakes of 2010-2011 have once again raised awareness of the vulnerability of unreinforced masonry (URM) buildings to severe damage and collapse in moderate and strong ground shaking and the immediate need for effective seismic mitigation policies. This lesson has reverberated strongly in Victoria, British Columbia, a community with many similarities to Christchurch, New Zealand, including colonial history, historic masonry construction practices, population (approximately 350,000), importance of tourism to the economy, and, most importantly, seismic hazard. Figure 1 provides the design response spectra used to determine seismic design forces for buildings on soft soils for Victoria and Christchurch for return periods of 475 and 2475 years. The similarities are obvious, particularly when it is considered that most URM buildings would be assessed to have a short period and hence the design earthquake forces in Victoria would be governed by the National Building Code of Canada (NBCC) short-period cutoff [1] shown in Figure 1, making the elastic design forces in Victoria only 9% higher than those used in Christchurch. Figure 1 also indicates that the demands from the 22 February 2011 Christchurch Earthquake were similar to the uniform hazard spectrum for a 2475 year return period, often referred to as MCE demands, for both cities.

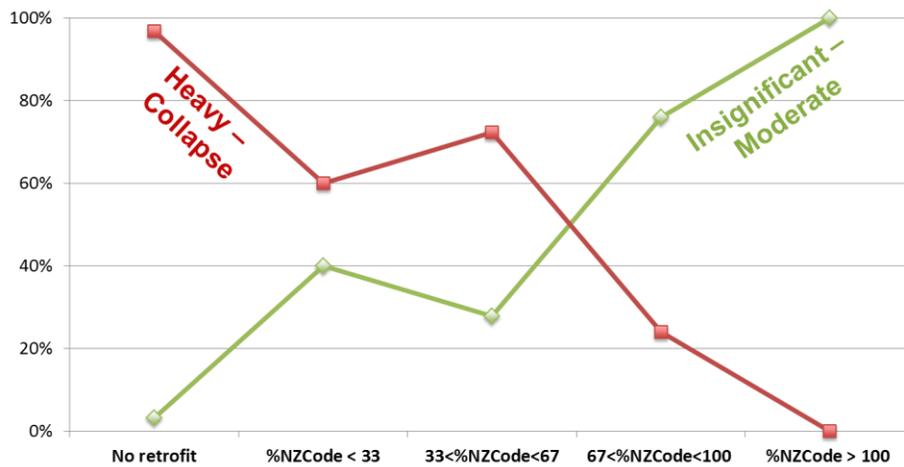
**Figure 2: Relationship between retrofit level and observed damage from 22 February 2011 Christchurch Earthquake** (data based on ATC-38<sup>†</sup> assessment [4] for 125 URM buildings from Ingham and Griffith [2])

Similar to many cities in seismically active regions, Christchurch City Council had initiated a passive earthquake strengthening program for URM buildings prior to the Canterbury Earthquakes, where changes in use or major alteration would trigger the need to retrofit existing buildings. After the earthquakes, 370 URM buildings were surveyed [2] to estimate the extent of retrofits achieved through this policy. The survey indicated that 22% of the buildings had comprehensive seismic retrofits (including strongbacks for out-of-plane wall support and/or supplementary in-plane bracing), 40% had partial retrofits (including connections between walls and wood diaphragms, with the remaining 38% not showing any evidence of seismic retrofit. To improve the economic practicality of seismic retrofits, it is common not to design for the full earthquake forces required by the building code for new buildings. Based on statistics collected by Ingham and Griffith [2], Figure 2 illustrates the observed performance of URM buildings with different levels of retrofits (relative to the design seismic forces required by the New Zealand Code) [3].

The results of the survey clearly indicate the improved performance of buildings with strong retrofits relative to those with no or limited retrofits. This lesson is not new, but the Christchurch Earthquake has presented an opportunity to raise awareness of the pressing need for seismic retrofitting of URM buildings internationally.

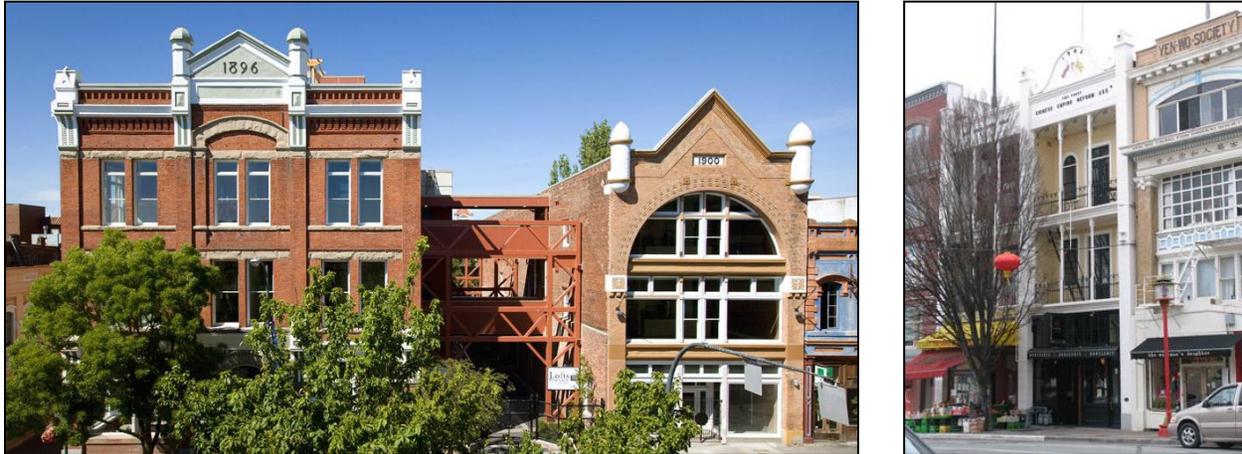
**Figure 4: a) Leiser & Thomas Earle Buildings (left); b) Chinese Empire Reform Bldg (right)**

A number of seismic retrofit projects in Victoria have involved innovative structural approaches. For the 1896 Leiser building, a former grocery warehouse located at 524 Yates Street which had been converted to offices, the developer was faced with a major seismic upgrading problem as his objective was to convert this building and an adjacent structure, the 3 storey 1900 Thomas Earle Warehouse, into residential apartments. The two buildings were separated by a courtyard

which provided the engineer the opportunity to utilize three large steel frames within the courtyard to provide lateral bracing for both buildings (Figure 4a), while not interfering with the internal layouts of the new residential apartments. The cost of the project was \$10.9 million, of which seismic upgrading was \$1.2 million with completion in 2007 [7].

Another innovative approach was used in the rehabilitation of the 1905 Chinese Empire Reform Association building, a three storey Edwardian era building located at 1715 Government Street in Victoria's Chinatown (Figure 4b). The building retained much of its original historic interior on the third floor, including tongue and groove wood paneling on the walls and ceiling. The second floor had suffered a fire in the 1960's and had been substantially altered. The seismic upgrading strategy devised by the owner was designed to retain as much of the original interior historic fabric as possible. Therefore plywood diaphragms were designed for the second storey to be installed on the floor and the ceiling below the third storey so the original fir floor on the third floor could be preserved. The tongue and groove fir panelling was carefully removed and reinstated to allow for steel strong backs to be installed to brace the side brick walls. A steel frame was constructed to be inserted behind the façade and was designed with a three-inch tilt to accommodate the settlement of the structure which had occurred over time. The entire roof and attic structure was removed and replaced to facilitate seismic upgrading. The project received a President's Award in 2012 from the Hallmark Heritage Society [10].
